TECHNICAL REPORT N-70-10

**SURVEY OF GULF COAST
STRUCTURAL DAMAGE RESULTING FROM
HURRICANE CAMILLE, AUGUST 1969**

By U. S. Army Engineer Waterways Experiment Station, Vicksburg, Mississippi

April 1970

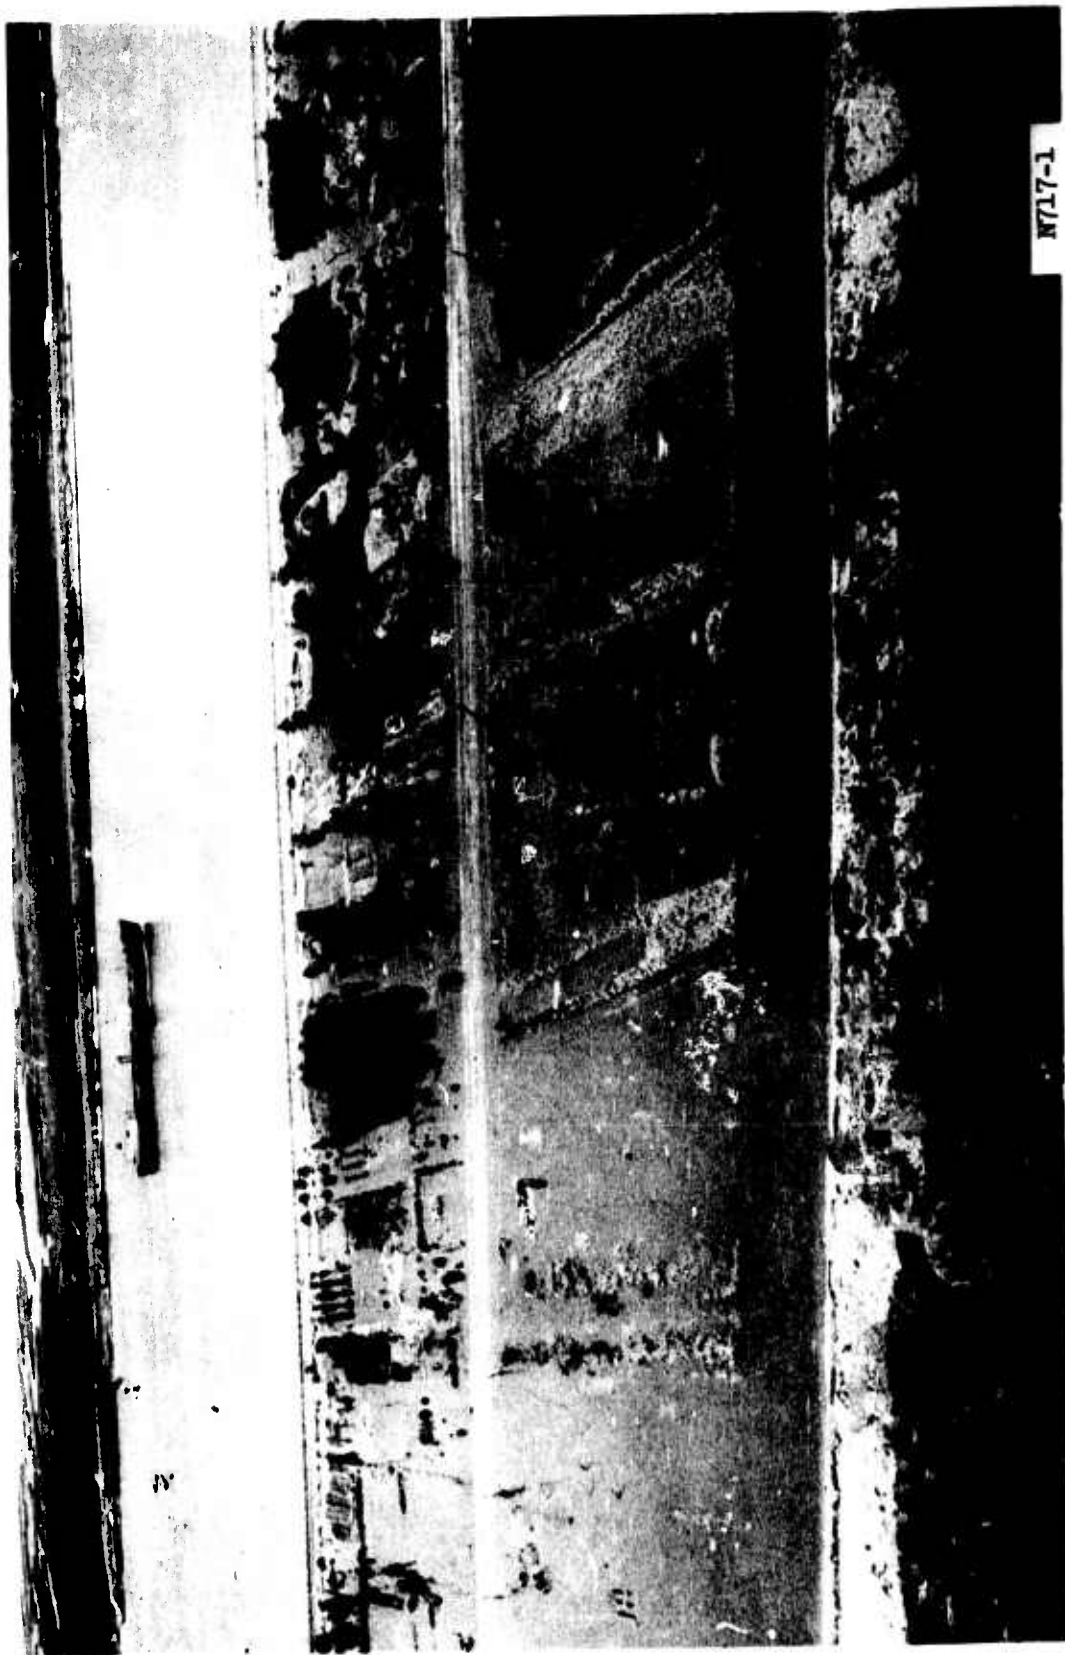
Figure 2.5 Damage near Buras, Louisiana.

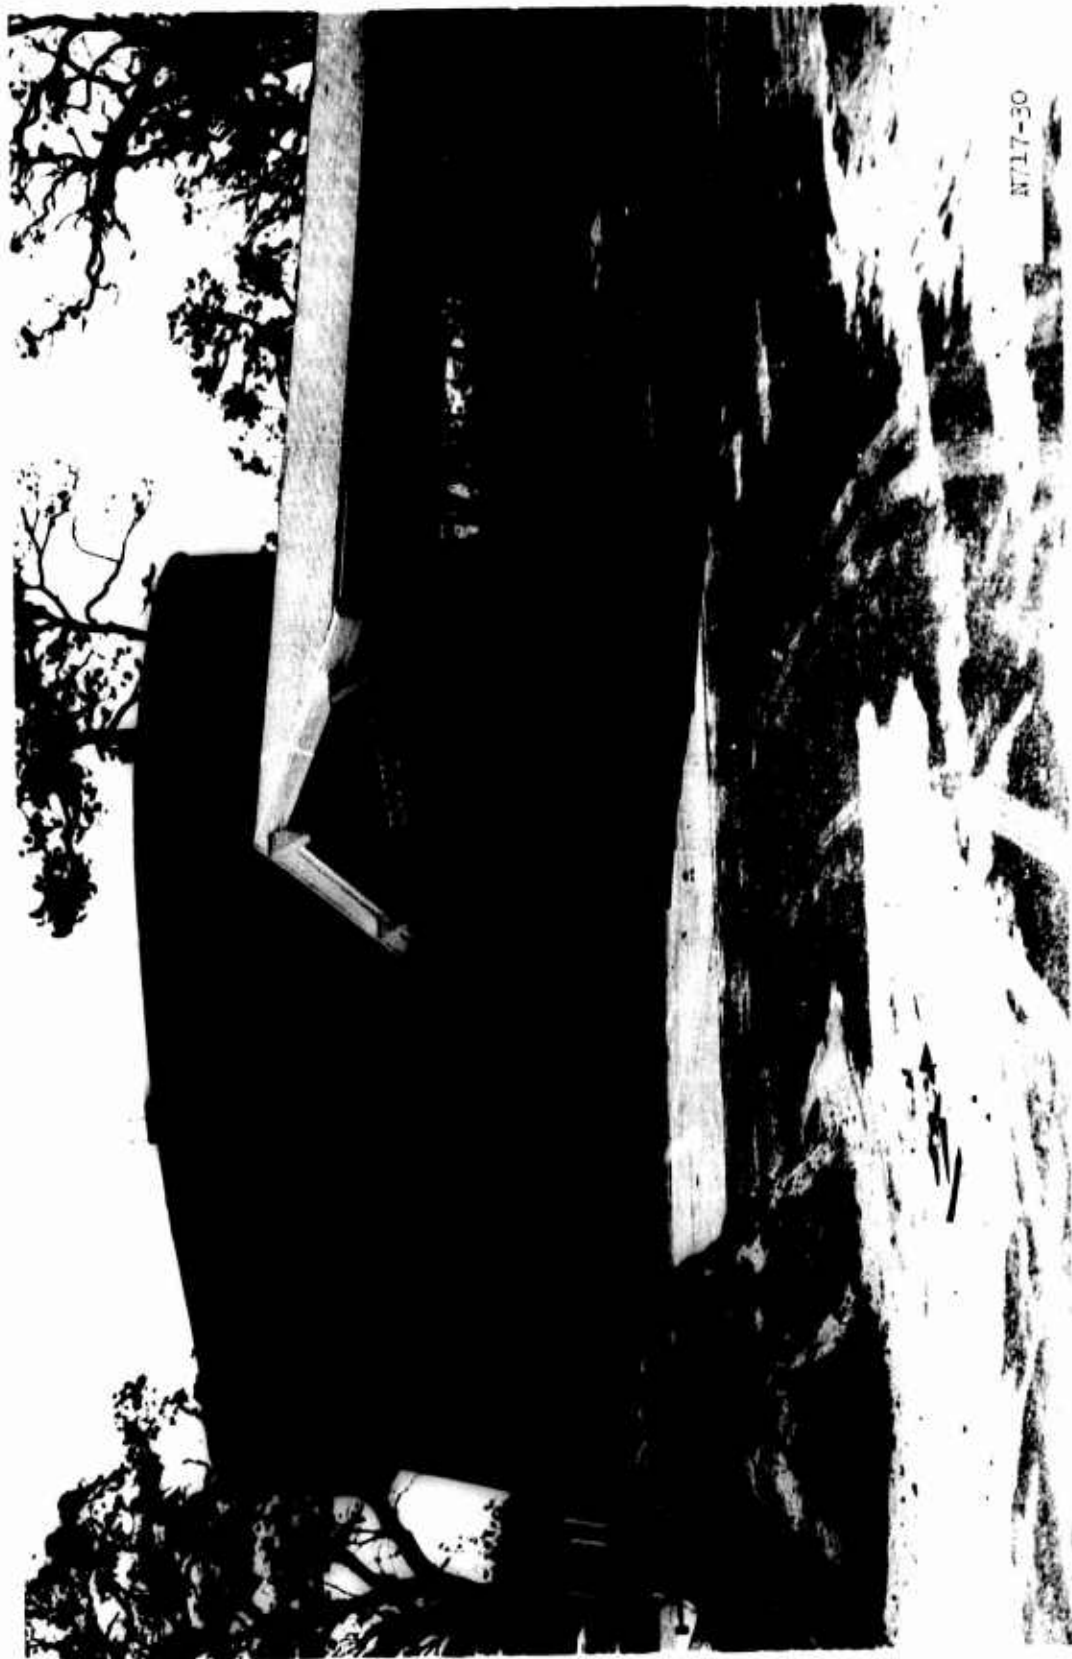
NT17-30

Figure 2.30 Tank floated in from harbor, west Gulfport, Mississippi.

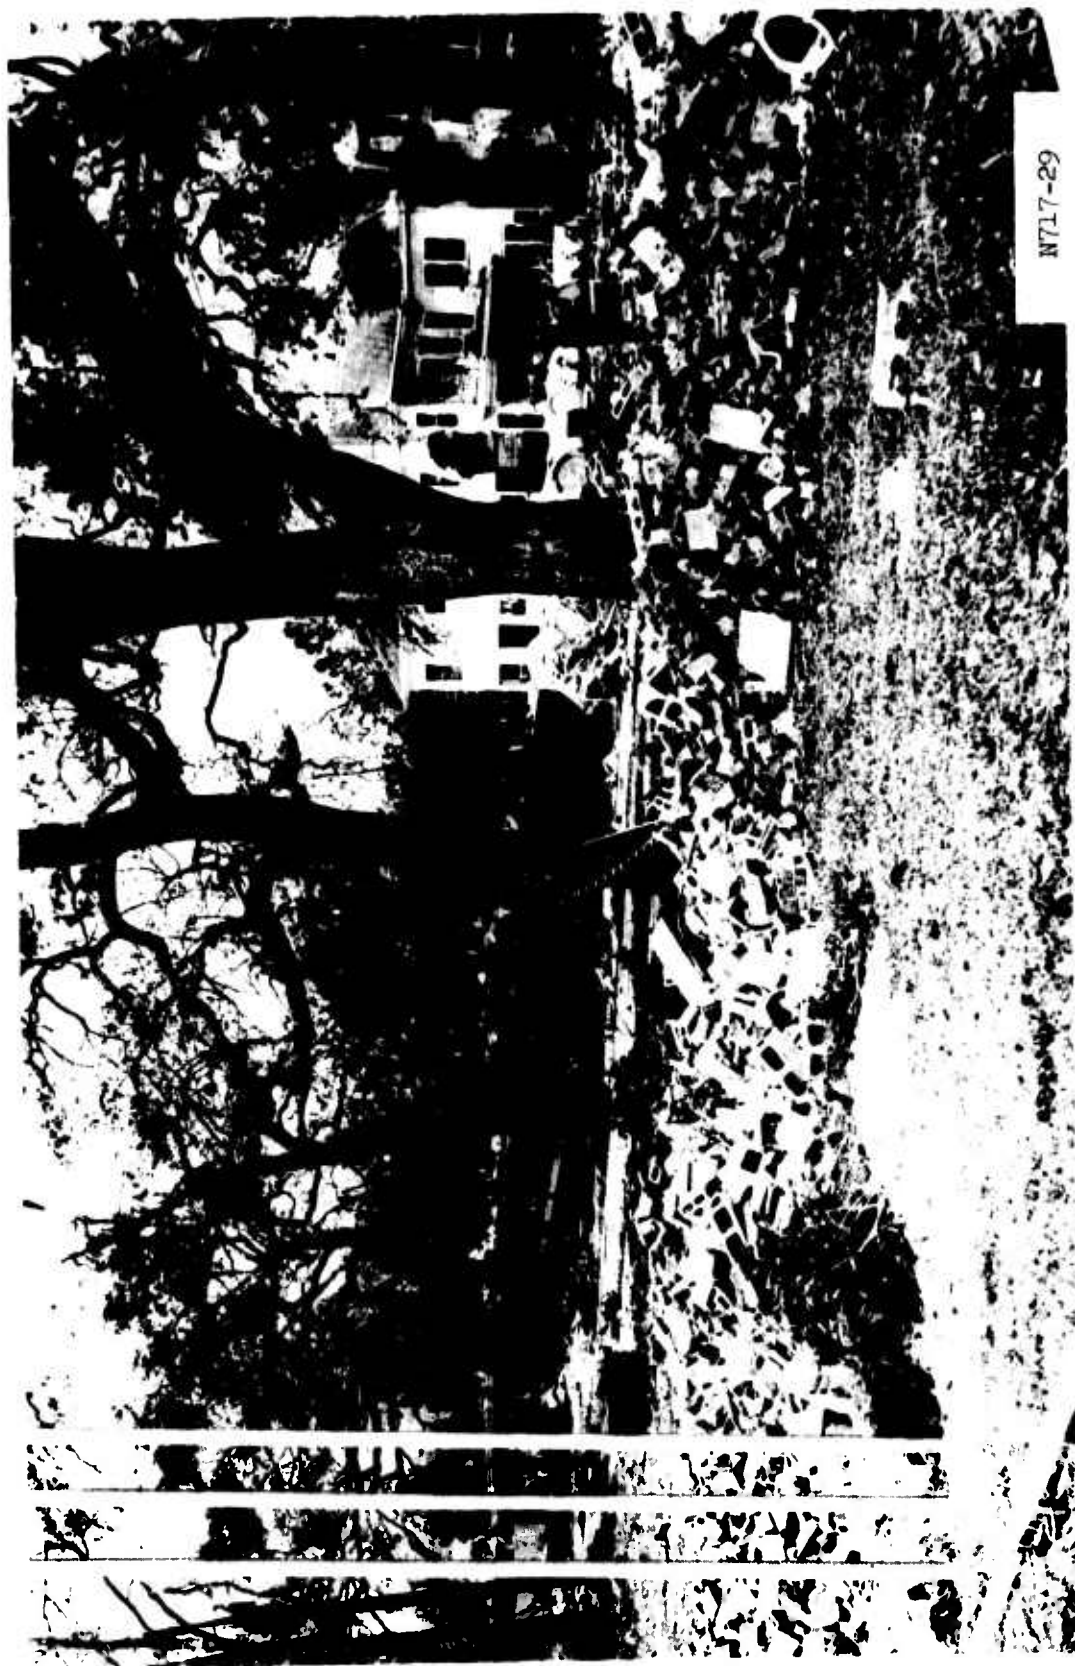
Figure 2.32 Barge, debris, and damaged residence, west Gulfport, Mississippi.

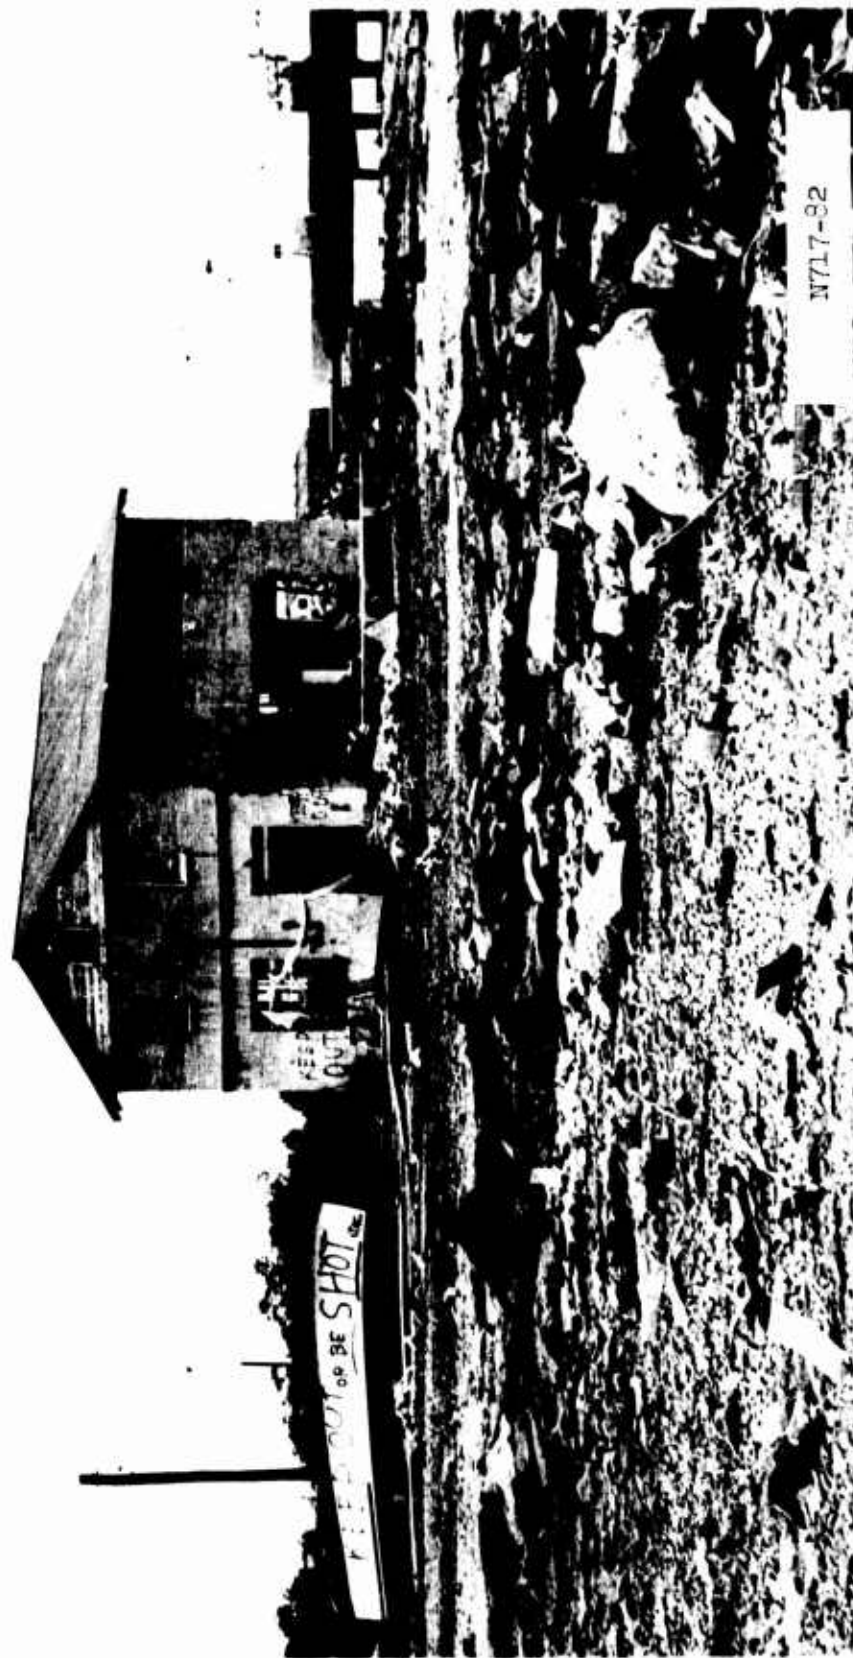
Figure 2.38 Water-damaged building, Back Bay of Biloxi.

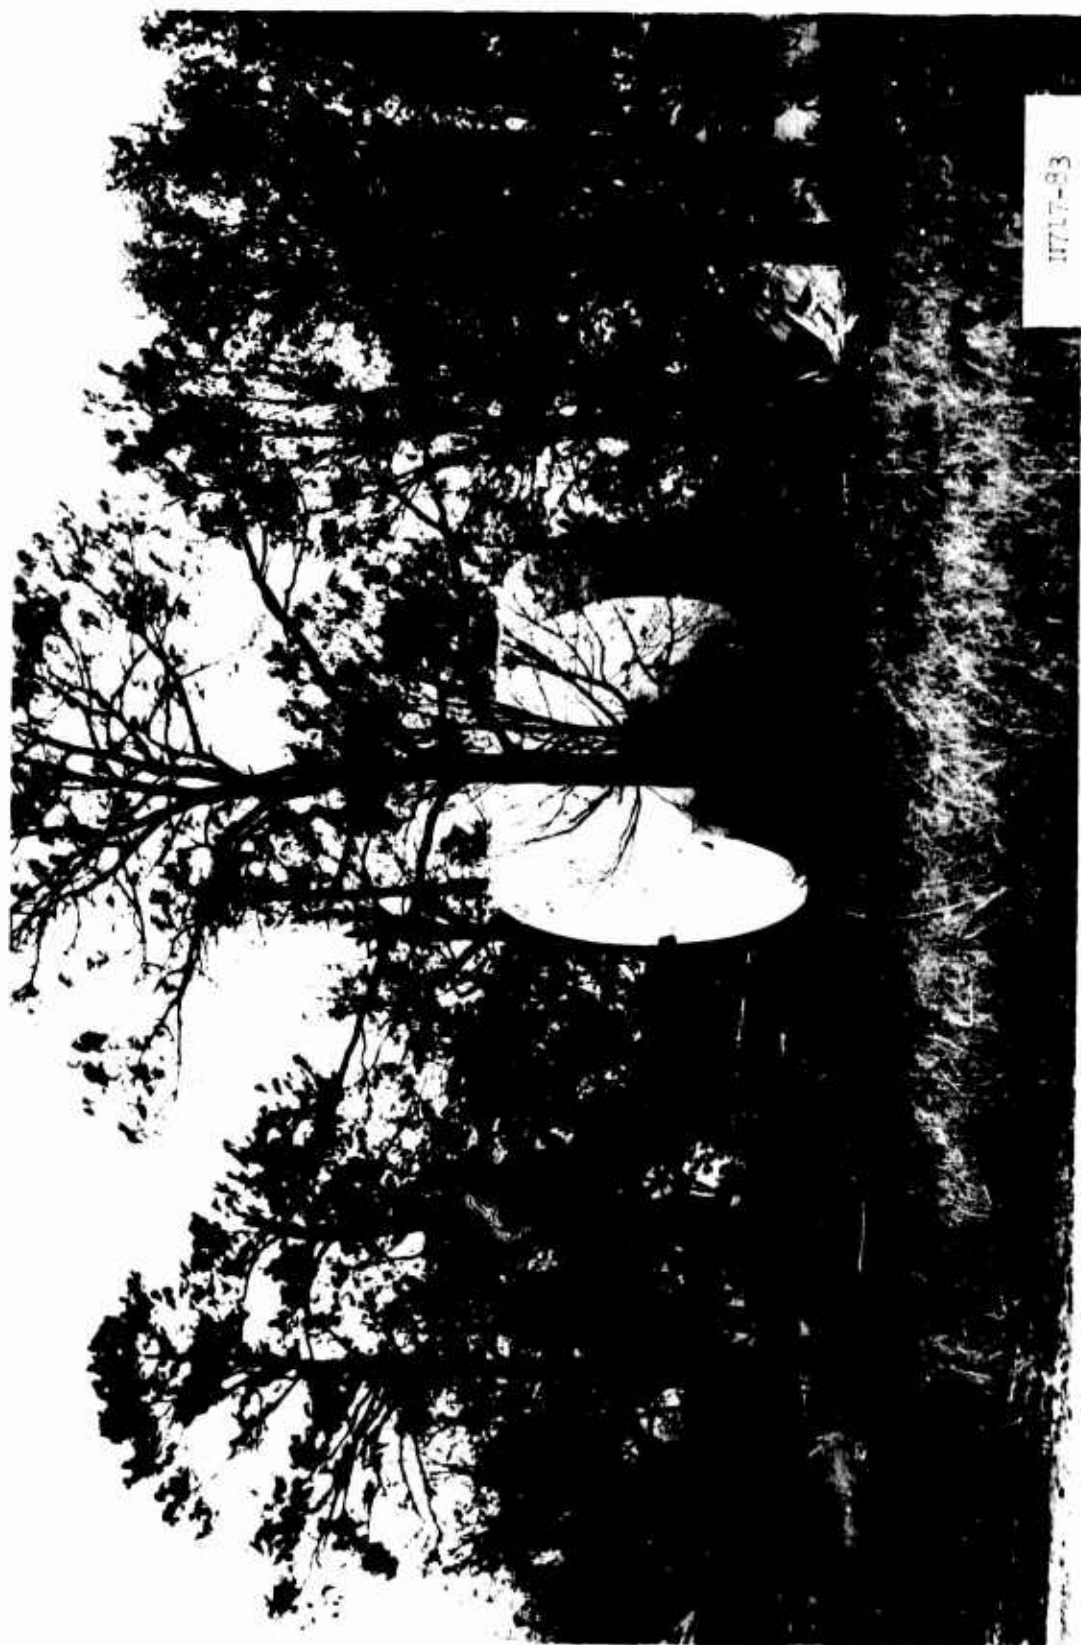
Figure 2.39 Oil storage tank floated inland, Back Bay of Biloxi.

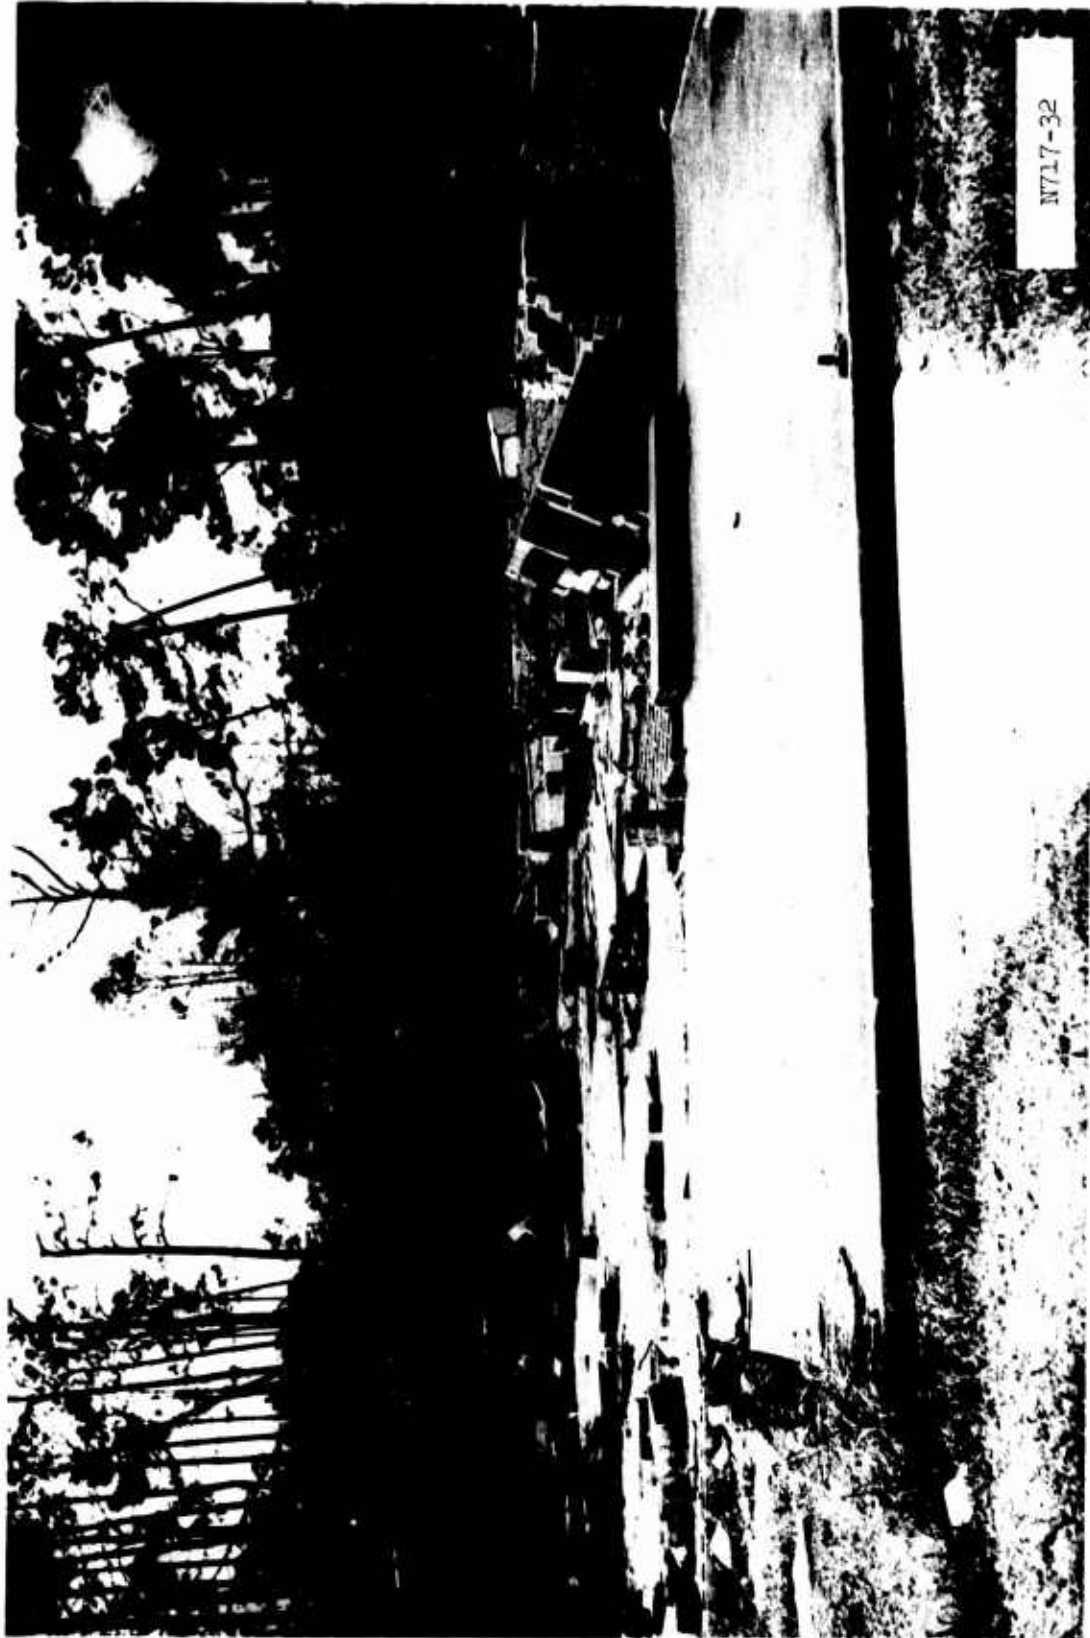
Figure 2.40 Remains of brick and block residence, Long Beach area.

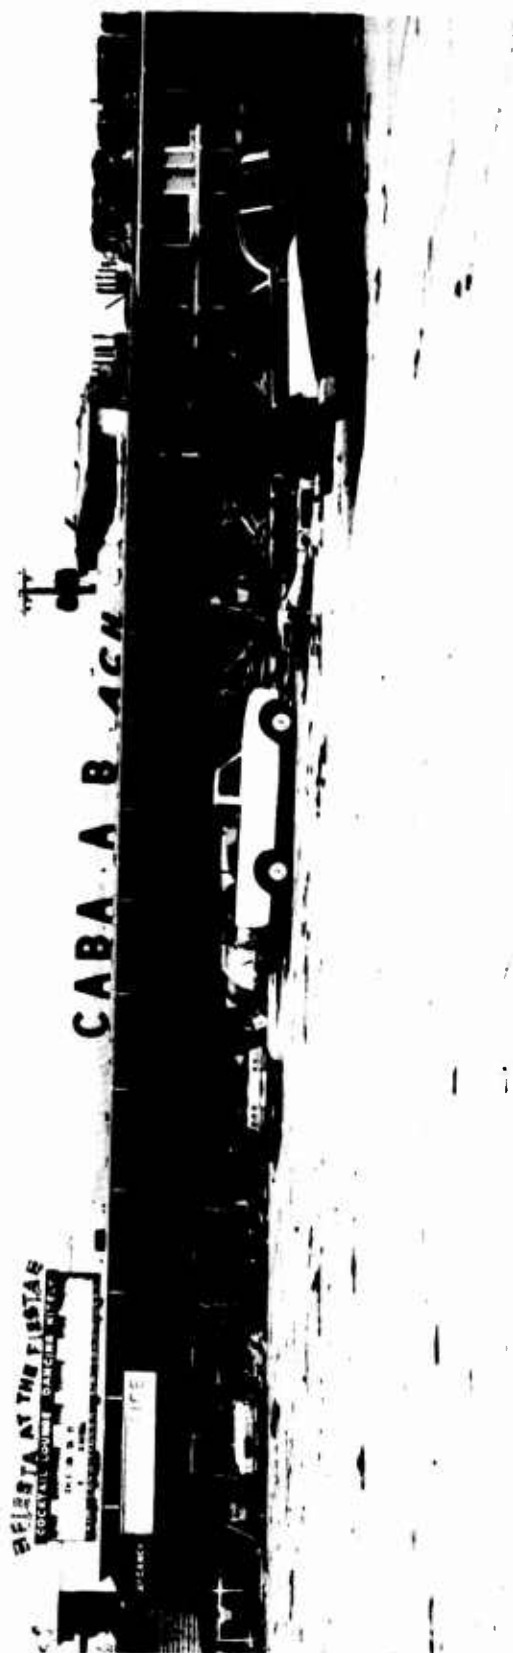
N717-79

Figure 2.52 Frame motel structure, Biloxi, Mississippi. There had been fire damage before the storm to the building shown at the right.

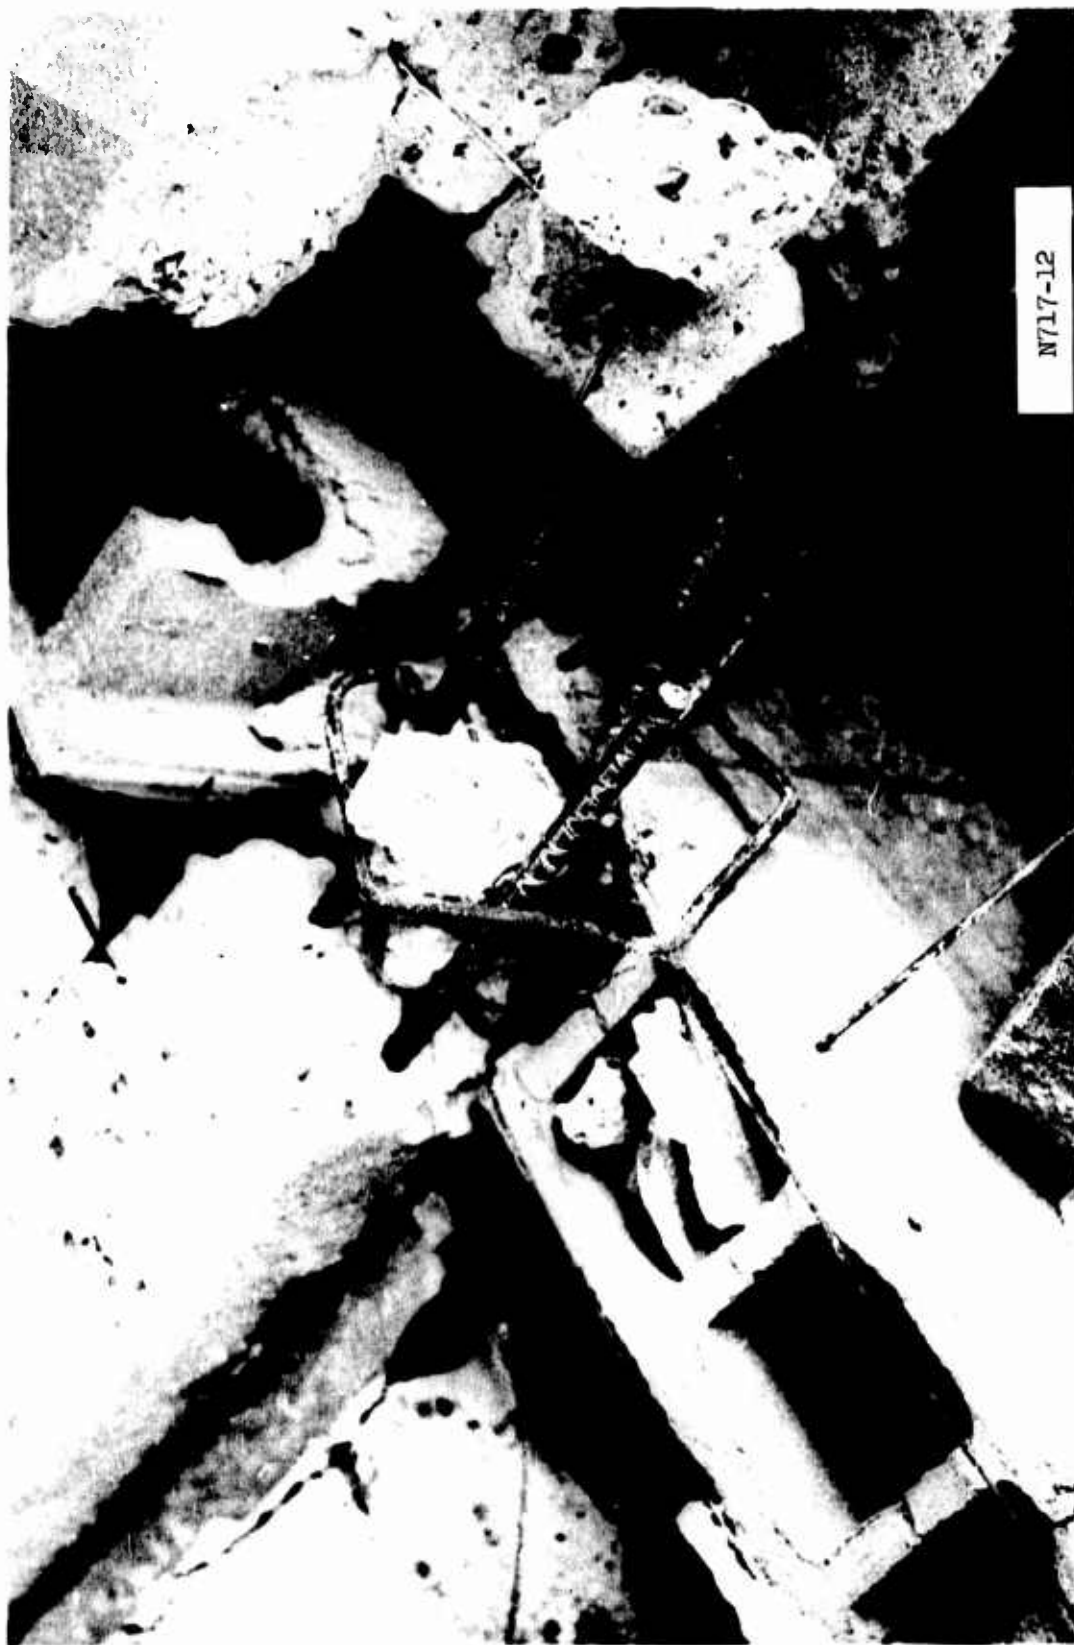
N717-12

Figure 3.21 Overhead view of beam failure over block wall, Marine Life.

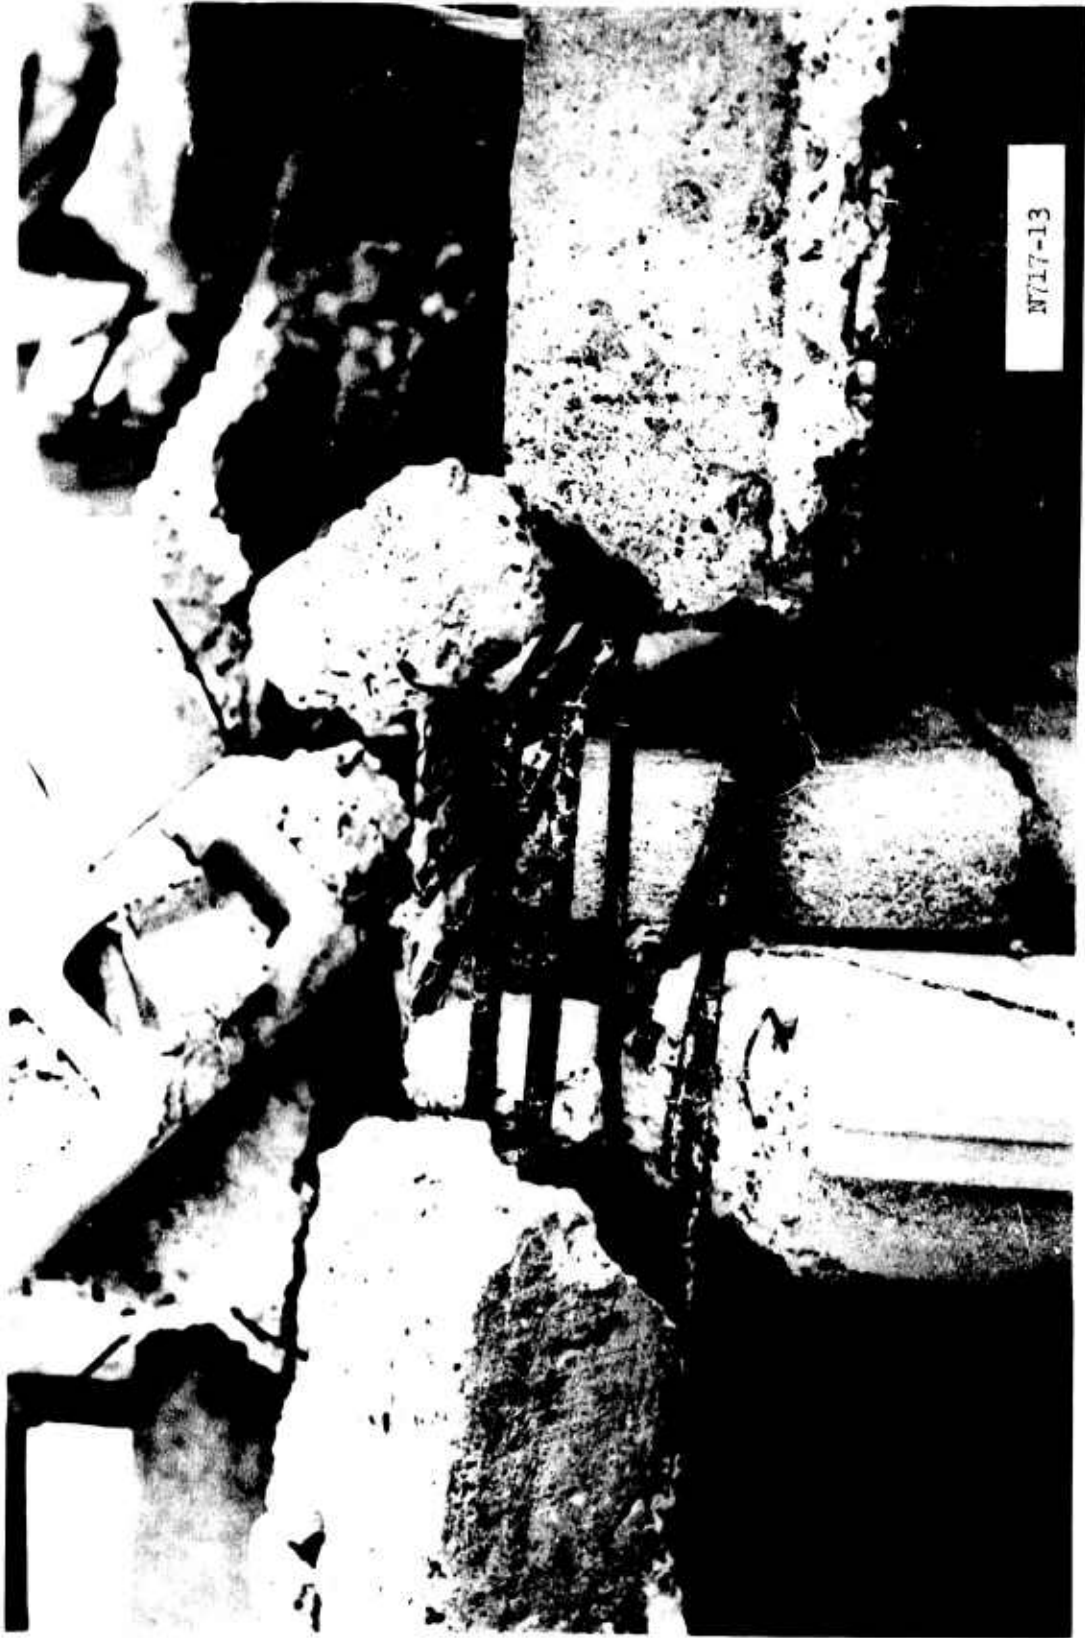
N717-13

Figure 3.22 Side view of beam failure over block wall, Marine Life.

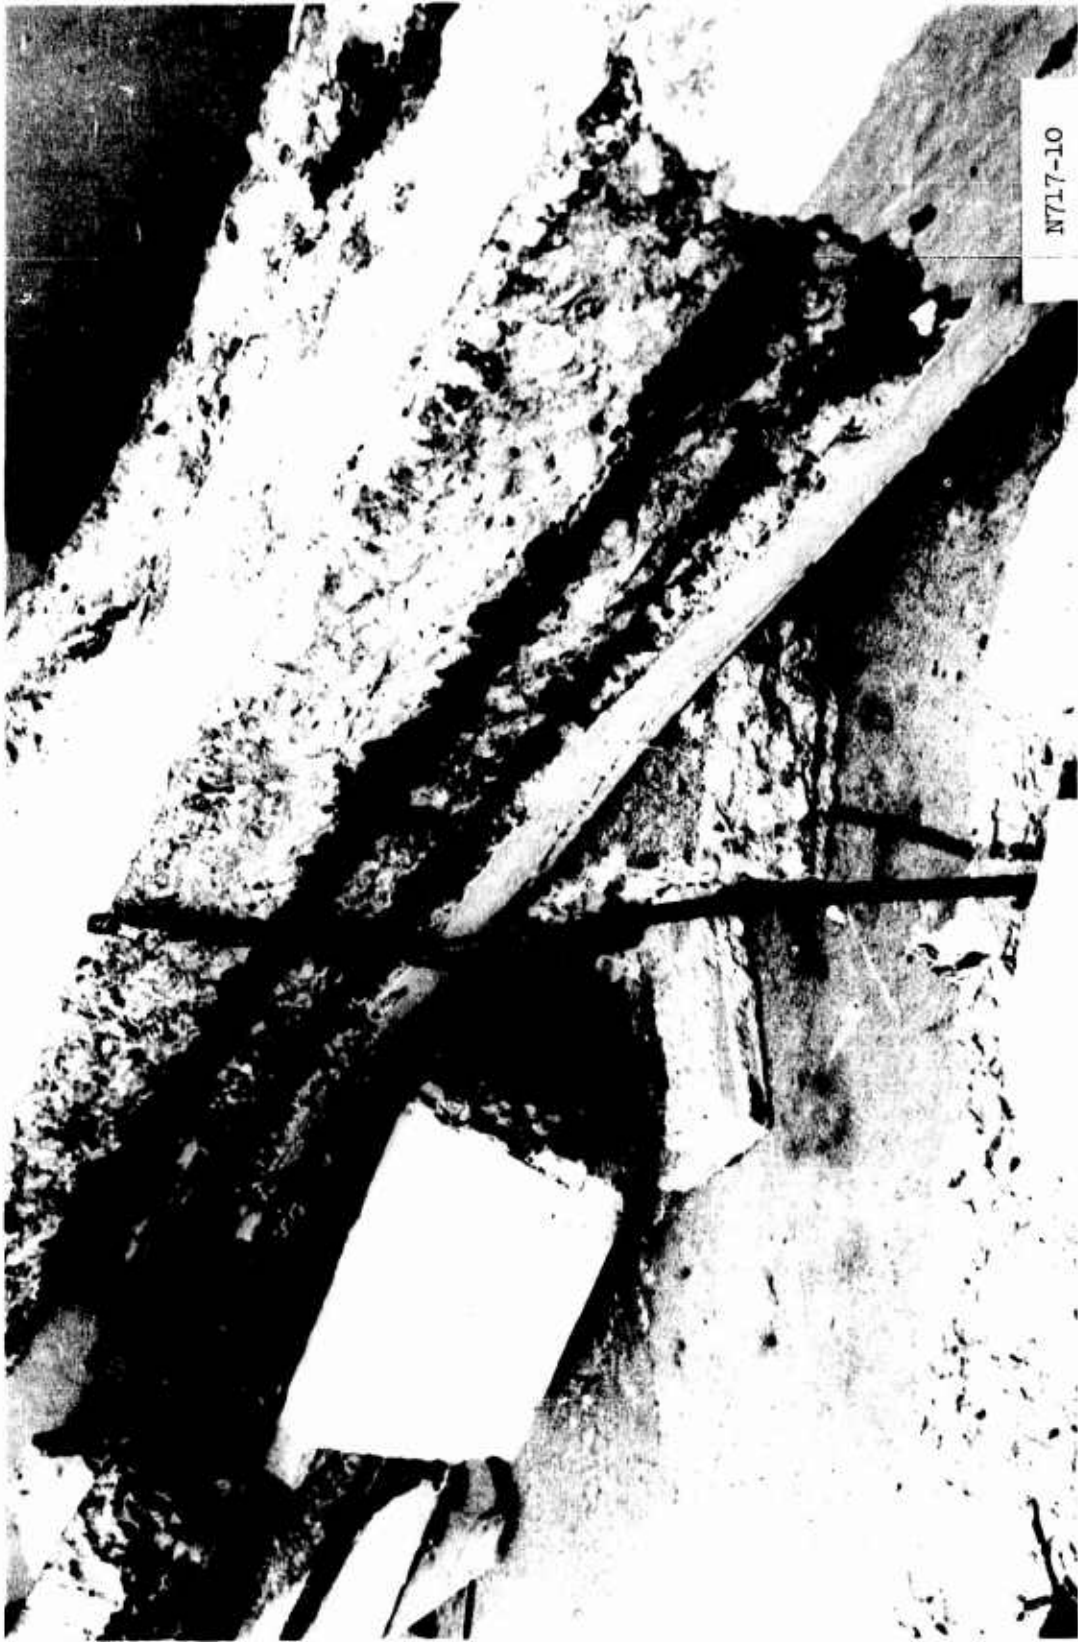
Figure 3.25 Reinforcement corrosion in a beam, Marine Life.

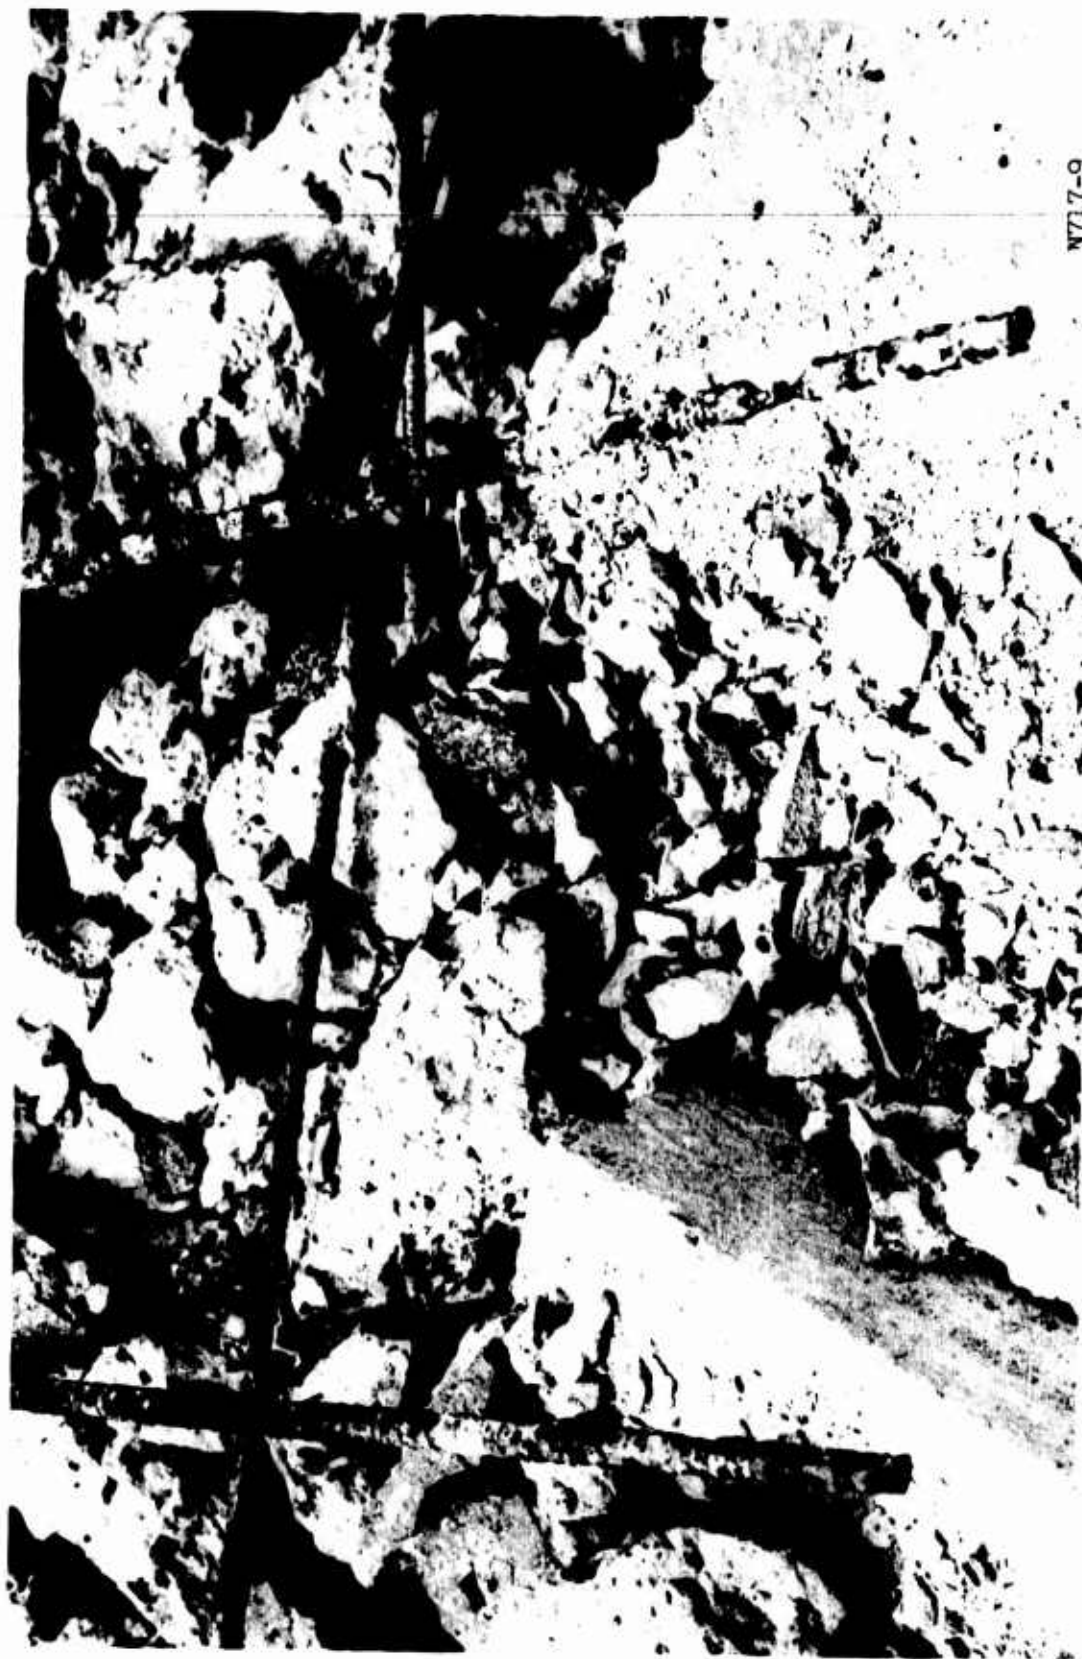
Figure 3.26 Reinforcement corrosion in a slab, Marine Life.

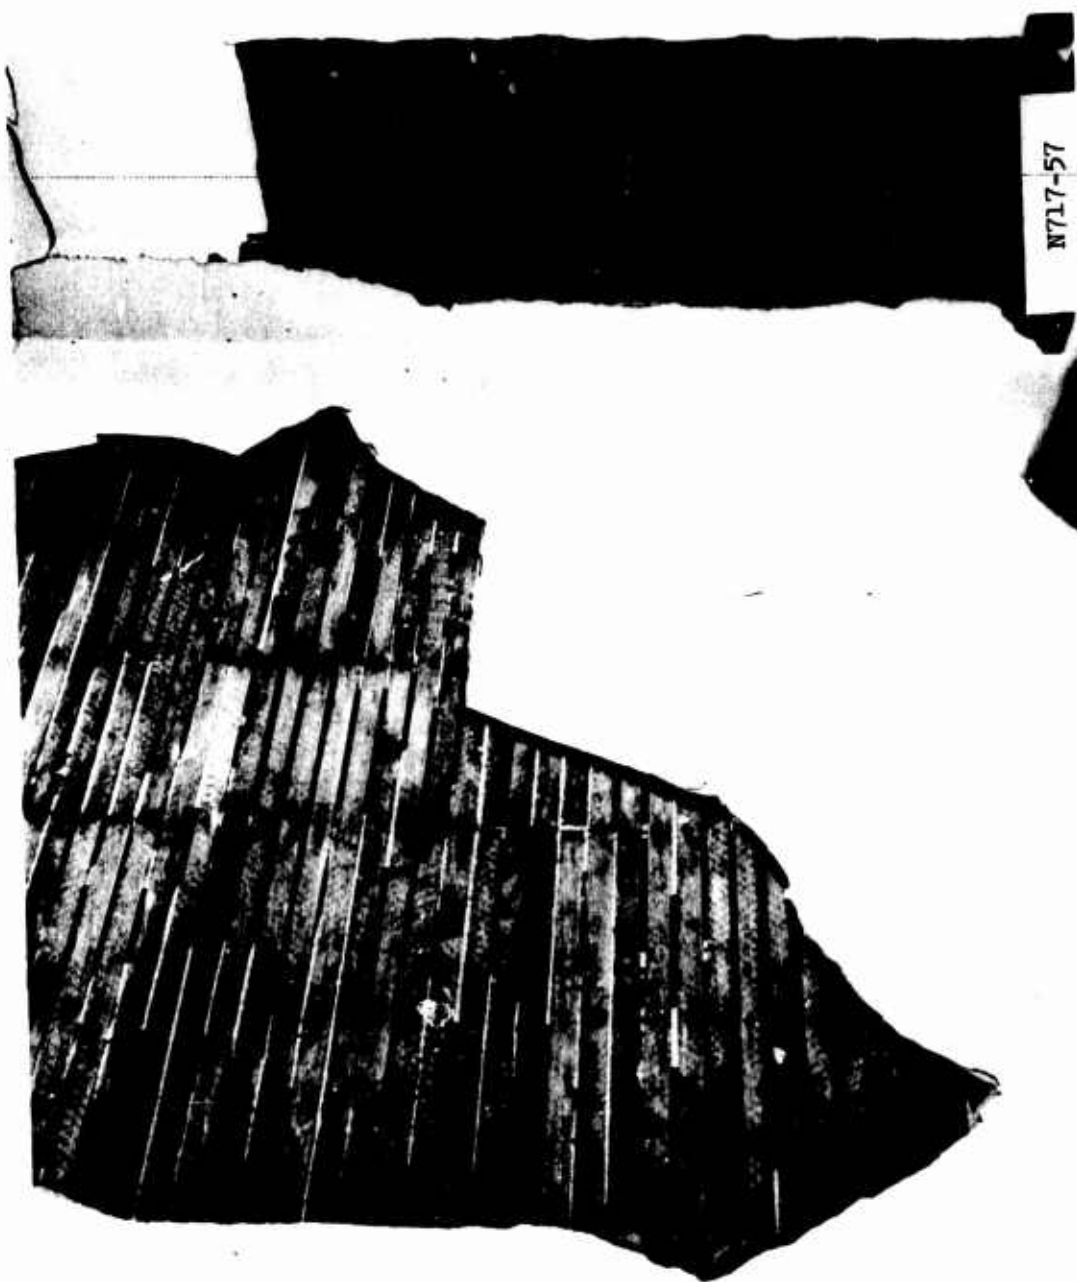
Figure 3.36 Wall damage, Pass Christian City Hall.

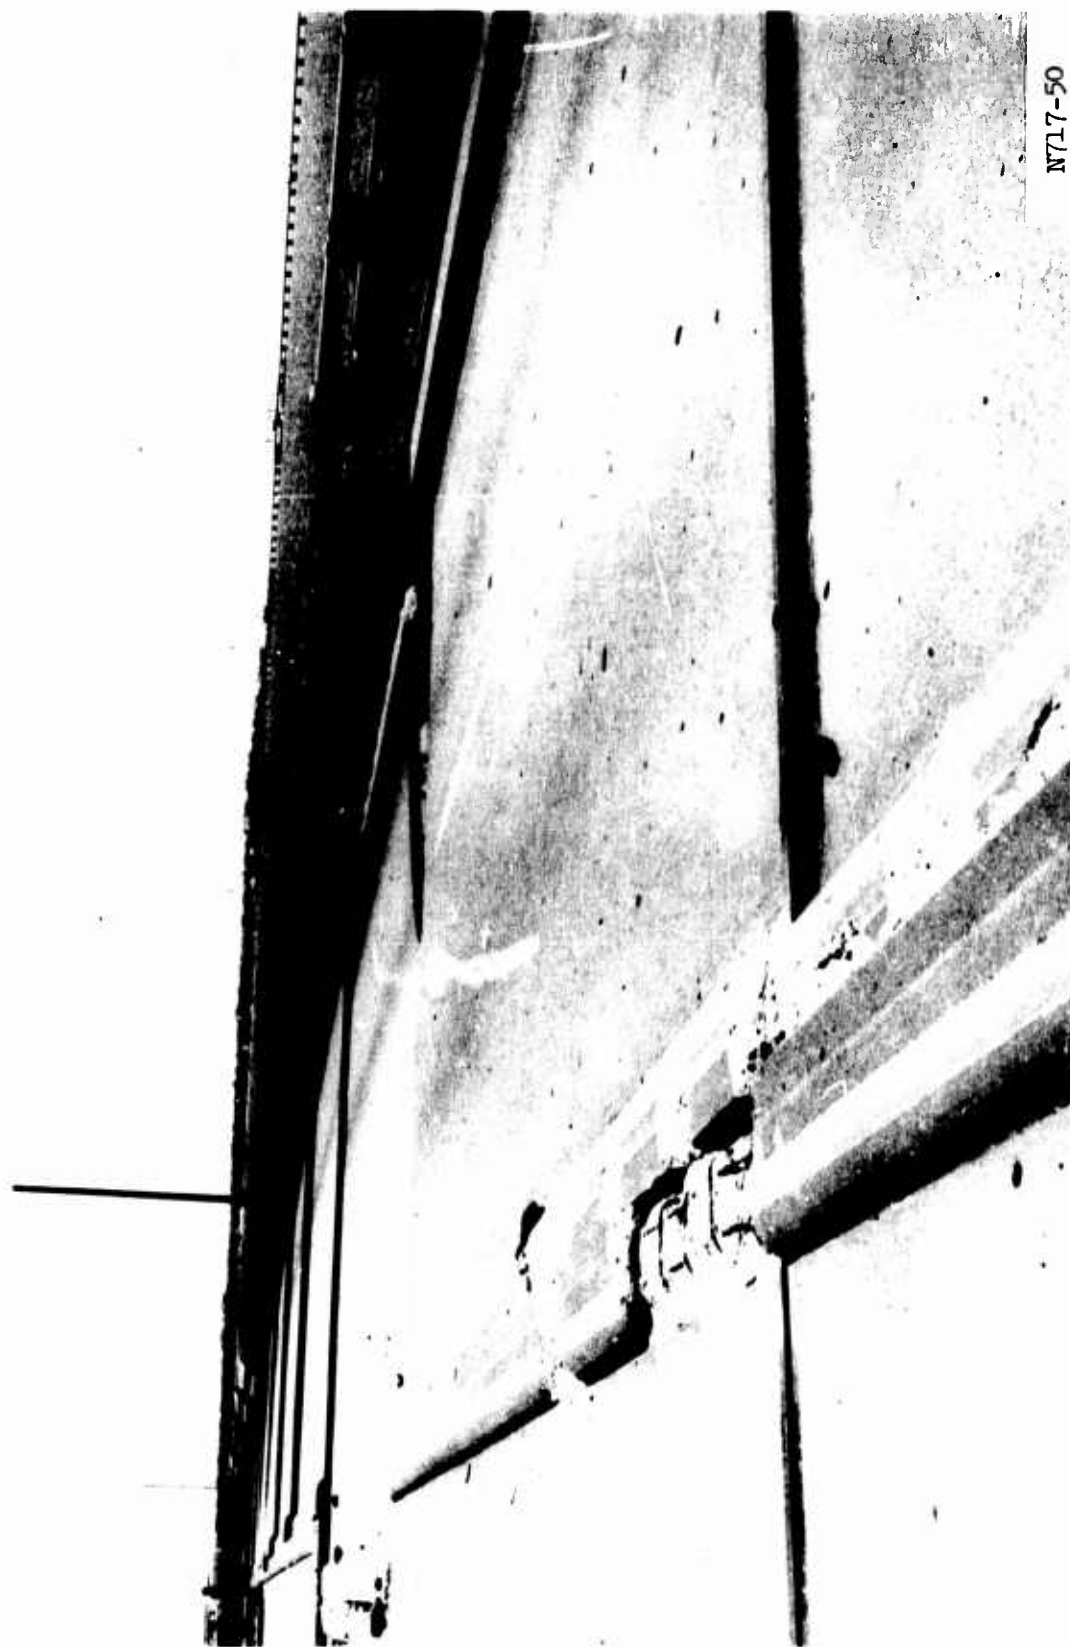
The water appeared to have lifted the seaward deck slabs up enough for the rocker bearings on the east end of each span to fall out, resulting in a sawtooth appearance along the south side of the bridge (Figures 3.52 and 3.53). Some of the railing sections were tilted inland, and all but one lamp was torn from its pole. One span was moved about 4 feet laterally (Figure 3.54). Considerable concrete was spalled along the bridge centerline where the two deck slabs joined. The west abutment was heavily damaged by wave action (Figure 3.55).

Figure 3.54 Displaced span of Bay Saint Louis Bridge.
